State Route-106 400 North in West Bountiful to US-89 in Farmington Level One Corridor Study

June 2007

UDOT
Planning Section

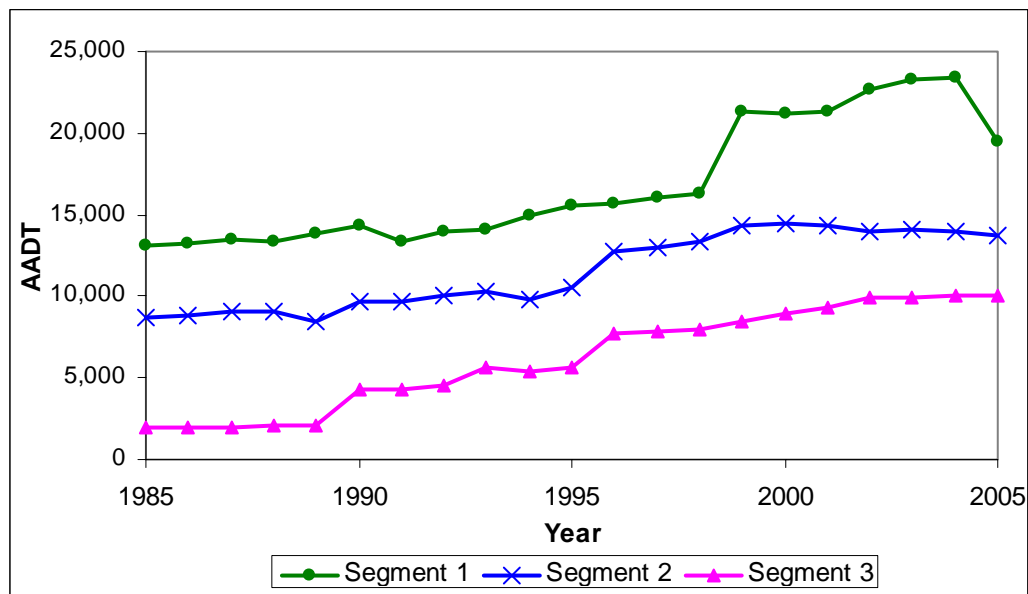
Figure 3 – Historic Traffic Trends

Traffic patterns varied widely from 1985 to 2005 along SR-106 as shown in Figure 3. For example, in Segment 1 there was a sudden rise in traffic volume in 1998 to 1999 of 32 percent and a fall in 2004 to 2005 of 17 percent. To compute historic growth rates, however, it was assumed that traffic growth on this corridor was linear from 1985 to 2005. Traffic growth in Segment 1 was five percent in the 20 years from 1985 to 2005, an average of 547 additional AADT per year. Traffic in Segment 2 grew at a rate of four percent per year (348 AADT per year based on 1985 volume) from 1985 to 2005. Traffic growth in Segment 3 during this same period was 36 percent per year, or 484 AADT per year based on 1985 volume.

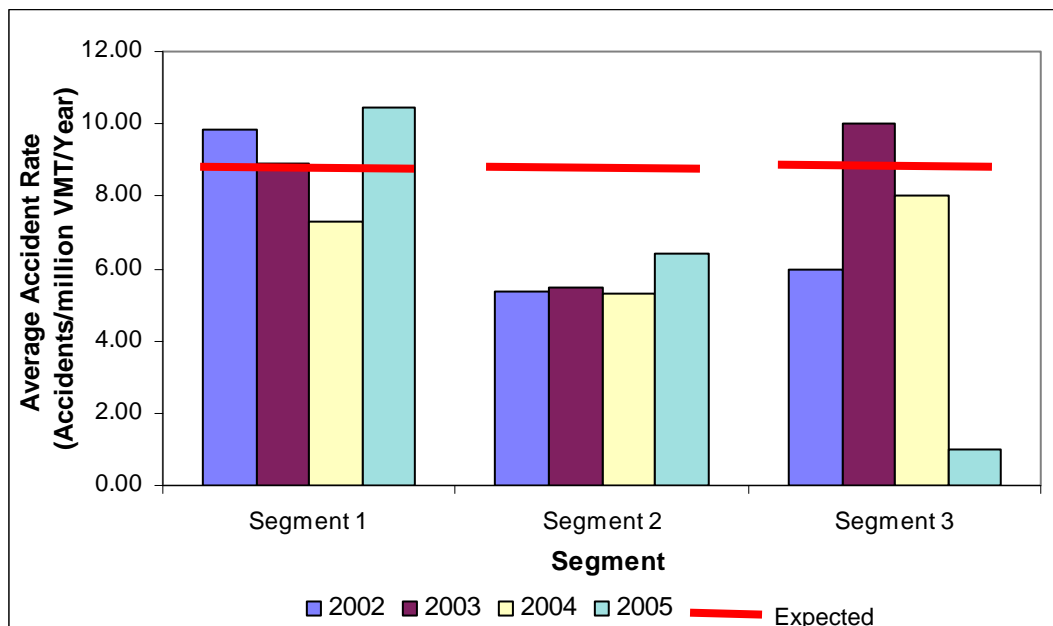
Figure 6 – Average and Expected Accident Rates

Figure 6 shows the average and expected accidents rates over a four year period. Expected accident values for each segment are shown as provided by UDOT for the years 2002 to 2005. Both average and expected accident rates are reported in number of accidents per million Vehicle Miles Traveled (VMT) per year. For an urban road, expected accident rate depends on the functional class of the roadway, AADT, and the population in close proximity of the roadway. SR-106 is classified as an Urban Minor Arterial.

The accident rate for Segment 1 decreased every year except in 2005 when the rate went up. Historic traffic trends have shown an increase in traffic volume in Segment 1 from 2002 to 2004 but a decrease in 2005. For Segment 2 the accident rate did not fluctuate during the four years analyzed. Similarly, traffic volume was almost constant during this time. In Segment 3 the accident rate increased from 2002 to 2003 but decreased every year thereafter. In 2005, the accident rate was 1.0. Historic traffic analysis has shown that traffic volume remained almost constant from 2002 to 2005.

In Segment 1, average accident rates were slightly higher than expected in 2002 and 2005. Segment 2 experienced fewer accidents than expected for the four years analyzed. Expected accident rate was only slightly exceeded in Segment 3 in 2003. Therefore, there are no serious accident concerns on this corridor.

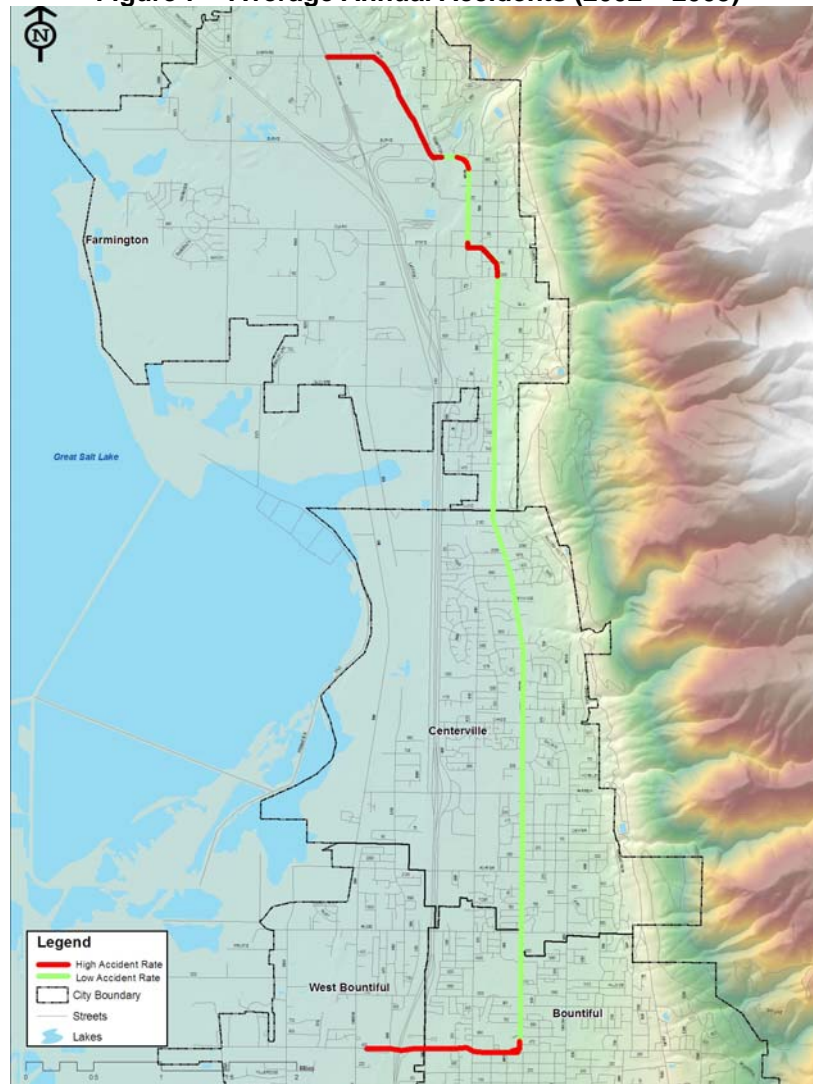
Figure 7 – Average Annual Accidents (2002 – 2005)

Analysis of accident data has shown that 70 percent of the total accidents occurred at the intersections. Approximately 90 percent of the accidents at intersections were right angle collisions between left turning traffic and opposing through traffic. The remaining 10 percent included rear end collisions, T-bone collisions, etc. Of the non-intersection accidents, 15 percent were head-on collisions and 15 percent involved vehicles roadway departure crashes. Two fatalities were reported in 2002. Other accidents resulted in different types of injuries or, possibly, no injuries.

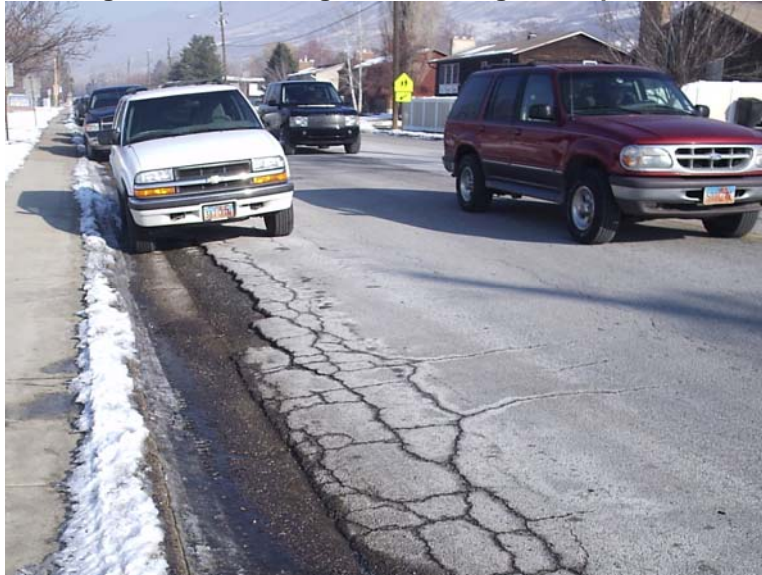
Figure 8 – Potholing and Cracking at Milepost 3.2

The UDOT Maintenance staff indicated that the outer lanes of SR-106 in Bountiful do not have a base course layer. The asphalt layers were built over a sand layer. The UDOT maintenance staff in Centerville cited that some trees planted on the western park strip at milepost 2.0 are creating sight distance problems for motorists, and they are obstructing pedestrians using the sidewalk. In Farmington, snow plowing has not been done promptly. The edges of the pavement are severely cracked and worn out at some locations in Centerville, as shown in the photo below taken at milepost 3.2.

1. At milepost 3.2, cracked and severely worn out edges of the pavement could be patched.
2. At milepost 2.0, trees on the western park strip could be evaluated for sight distance and pedestrian movement.
3. Water from springs in Farmington could be redirected so that it does not run across the road.
4. Re-striping at milepost 3.2 and various other locations would enhance visibility of travel lanes.

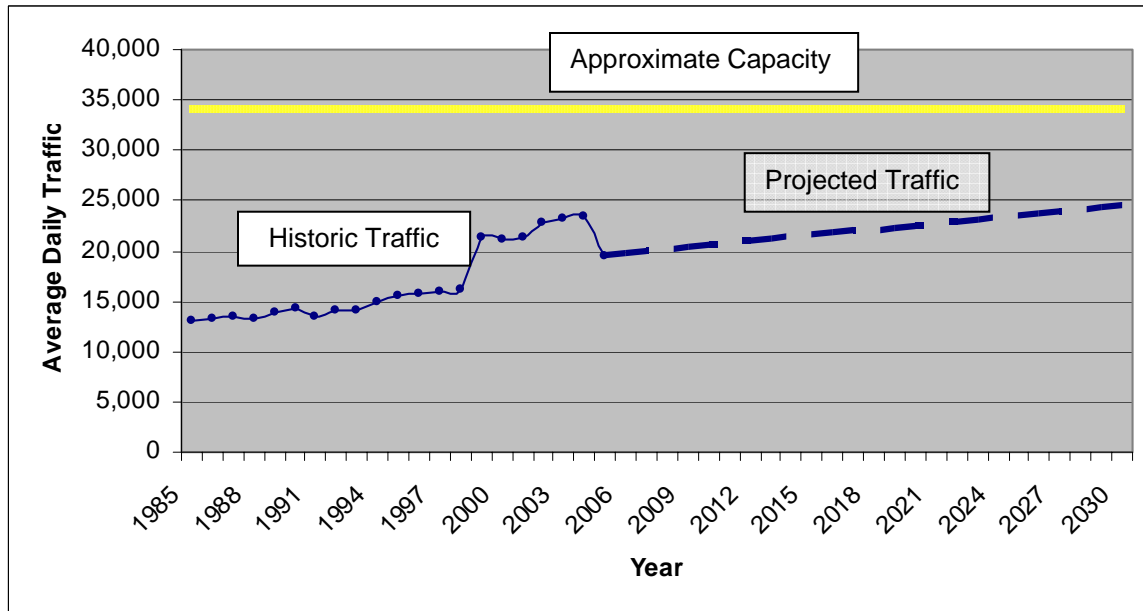
Figure 10 – Traffic Forecast for Segment 1

Two-thirds of Segment 1 of SR-106 is a four-lane highway with a center-turn lane, and the rest is a two-lane roadway. However, for analysis purposes, the capacity for the whole of Segment 1 has been estimated to be 34,000 vehicles per day which is the approximate capacity of a four-lane arterial. Figure 10 shows that this capacity will not be exceeded in the next 25 years. Segments 2 and 3 have two lanes, and the capacity is estimated to be 18,000 vehicles per day. It can be observed from Figure 11 that demand will not exceed capacity in these two segments by 2030. Therefore, there are no capacity issues anticipated on SR-106 by the year 2030.
